# al backstrom's FLYING PLANK

By Al Backstrom (EAA 1162)

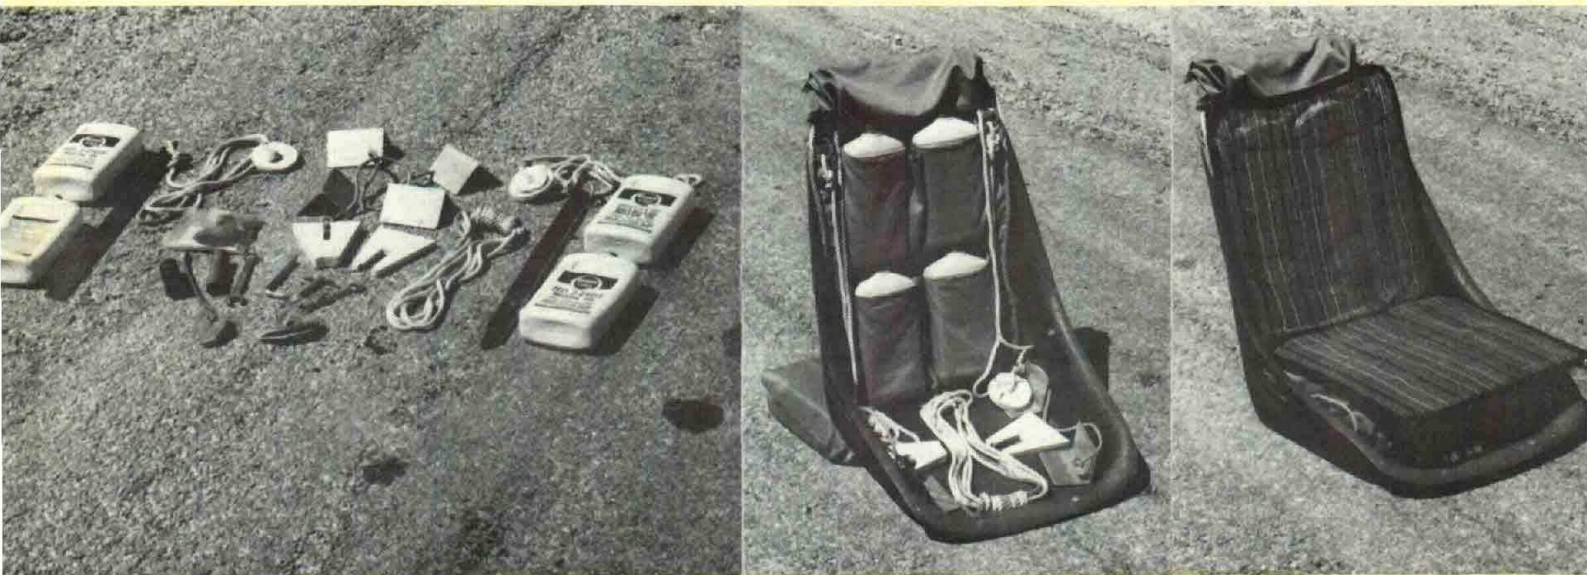
Left to right: 1) Stuff you need: Oil (4 qts.), tie-down kit, tools, etc., 2) Stuff, stuffed in seat in seatback pack and seat. Roll at top of seatback pack is for more tools, etc., 3) With seat cushions, as it will fit in the cockpit.

The only prerequisite for copying this idea is that you must normally use cushions in your seat to have the needed space. The following photos show my seat for the Plank.
